DC Magnetic Biased Tube Inspection

Items Inspected: Cooler B
Cooler C

Report Number: Kxx0-16

| Coolers B and C | Final Inspection Report | Kxx0-16 |

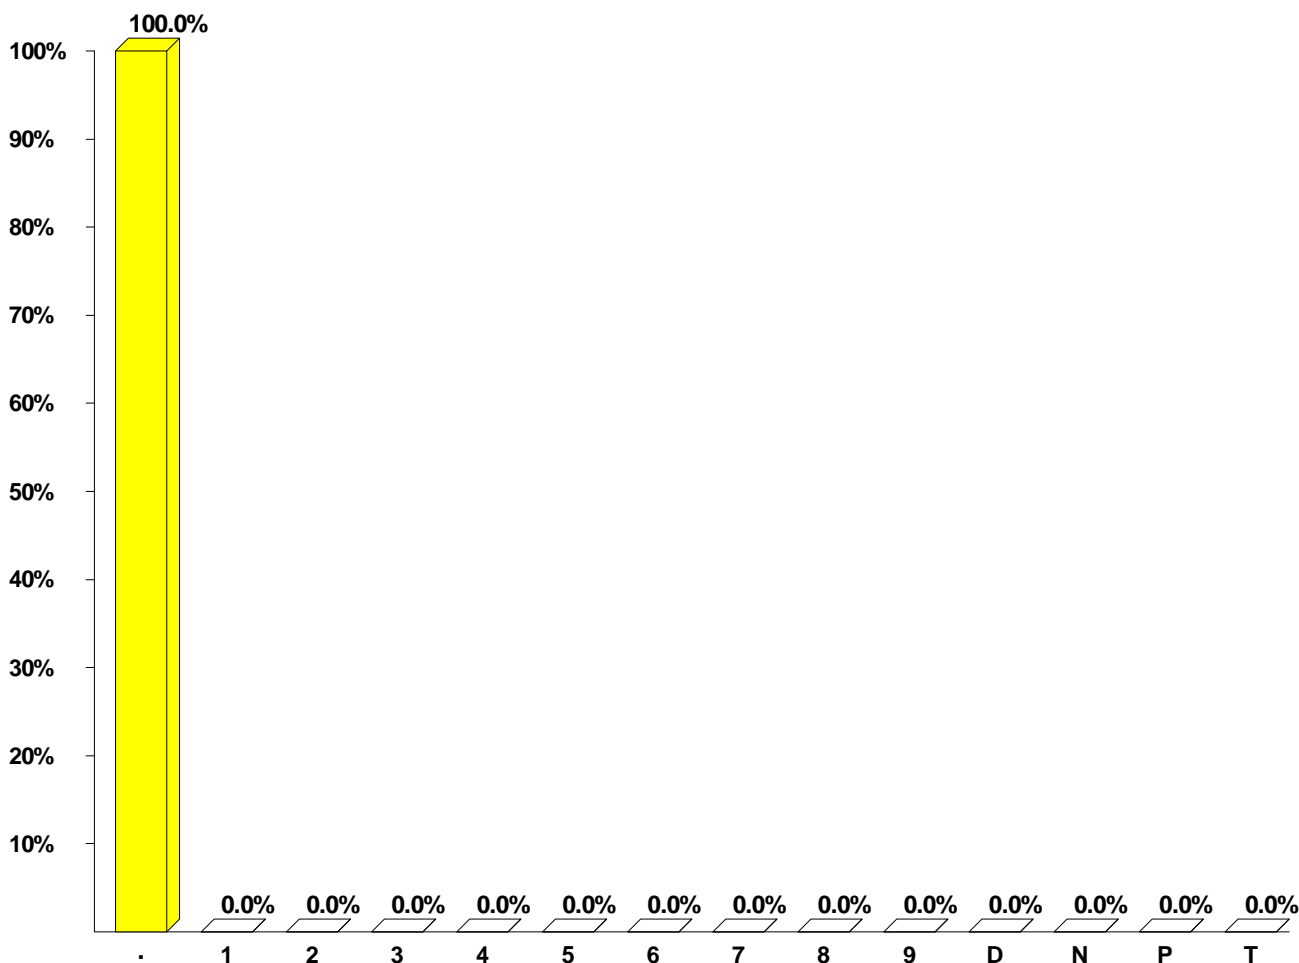
Cooler A - Statistic final result - Cooler A (100% = all tubes)

| [2] : all tubes with indication | 0 | | 0.0% from [1] | |

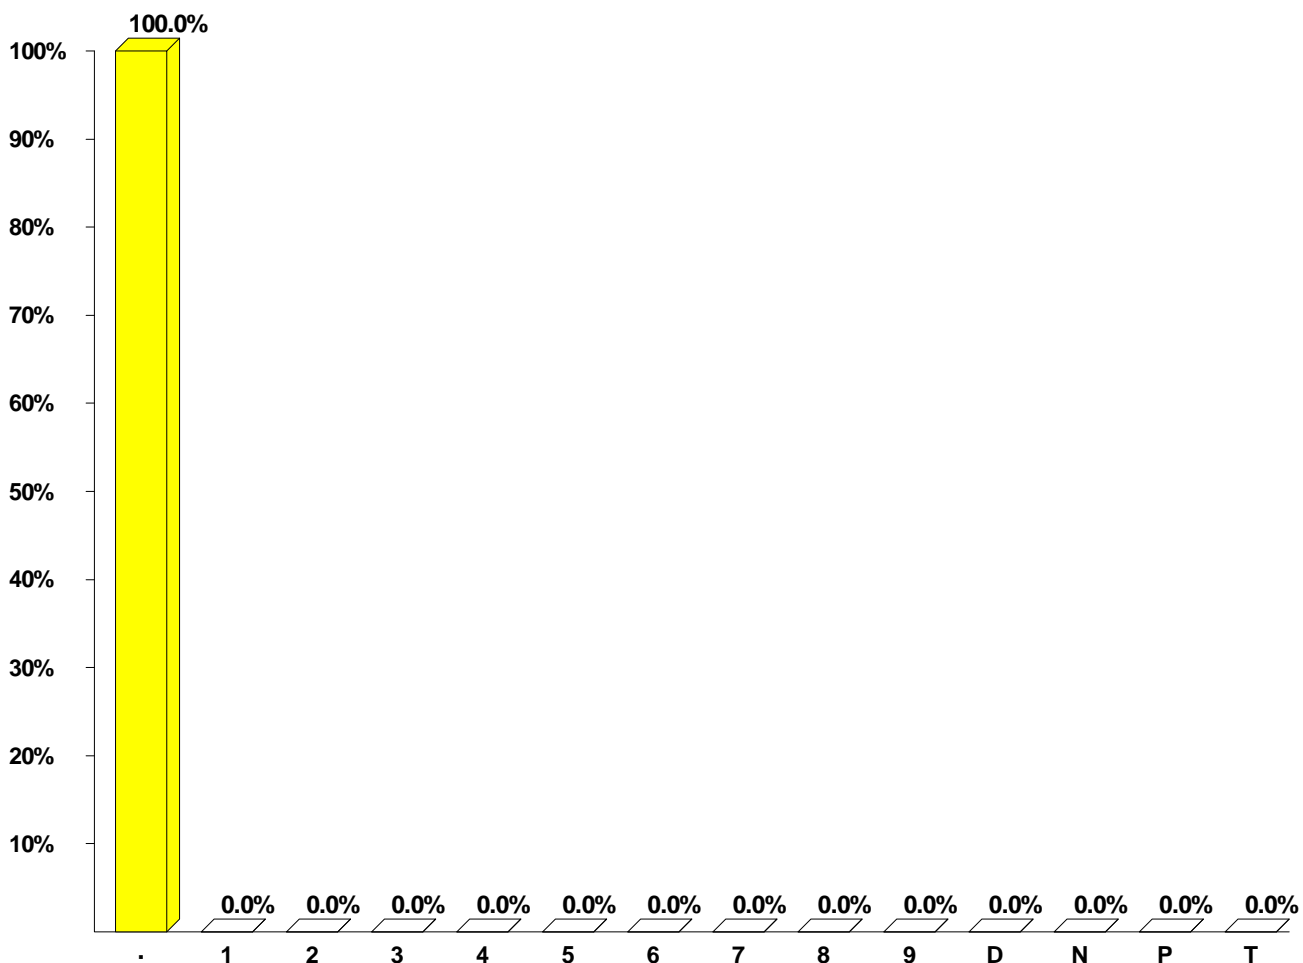
**Cooler B - Statistic
final result - 83D-EB6201B
(100% = all tubes)**

| [2] : all tubes with indication | 0 | | 0.0% from [1] | |
