MEC (Extended SLOFEC) Caisson Inspection

Item Inspected: 36" Caisson

Type of Report: Final Report

Report Number: Kxxx

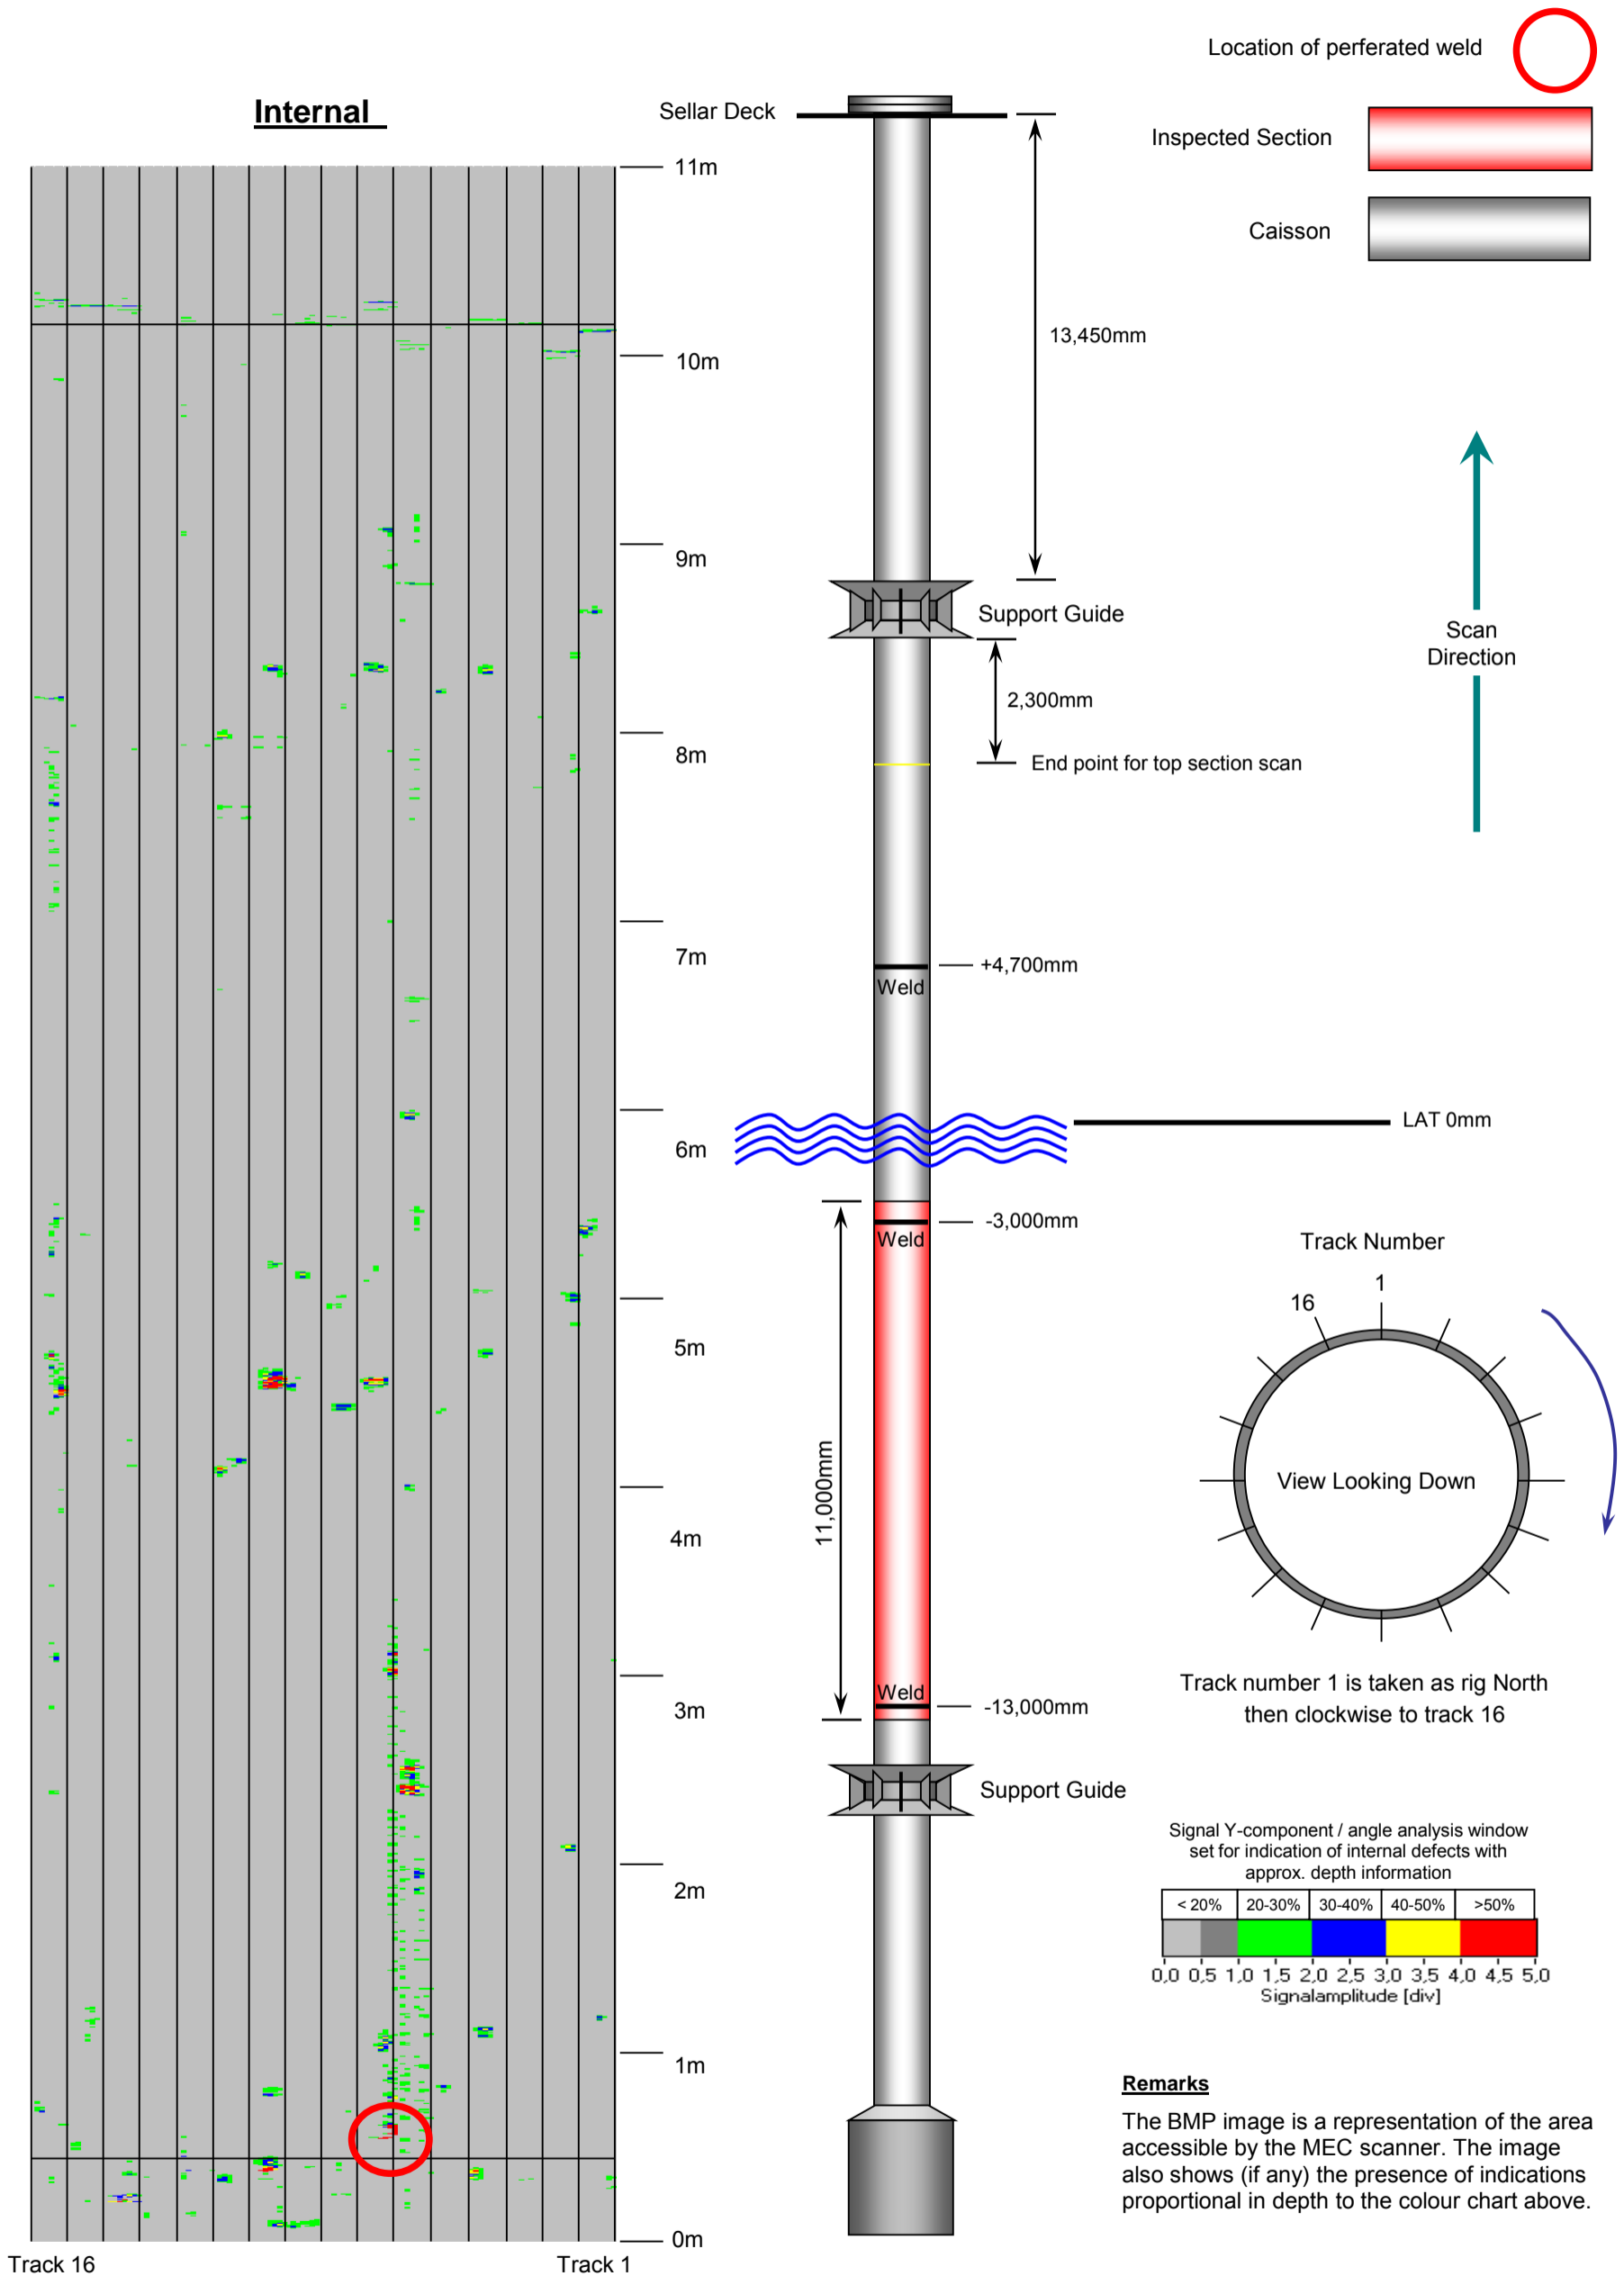
Indication View Section 1

Indications for Section 1 (13mm Wall)

TRACK Number	Distance form Start	Indication Depth	INT EXT	Notes
1	5.3m	40	In	Isolated indication
2	2.1m	40	In	Isolated indication
3				
4	1.1m + 8.3m	40% + 40%	In	Isolated indications
5				
6	2.5m + 6m	>50% + 40%	In	Isolated indications
7	3m + 4.5m	>50% + >50%	In	Isolated indications
8				
9				
10	4.5m	>50%	In	Isolated indication
11	4.1m	50%	In	Isolated indication
12				
13				
14				
15				
16	4.5m	50%	In	Isolated indication

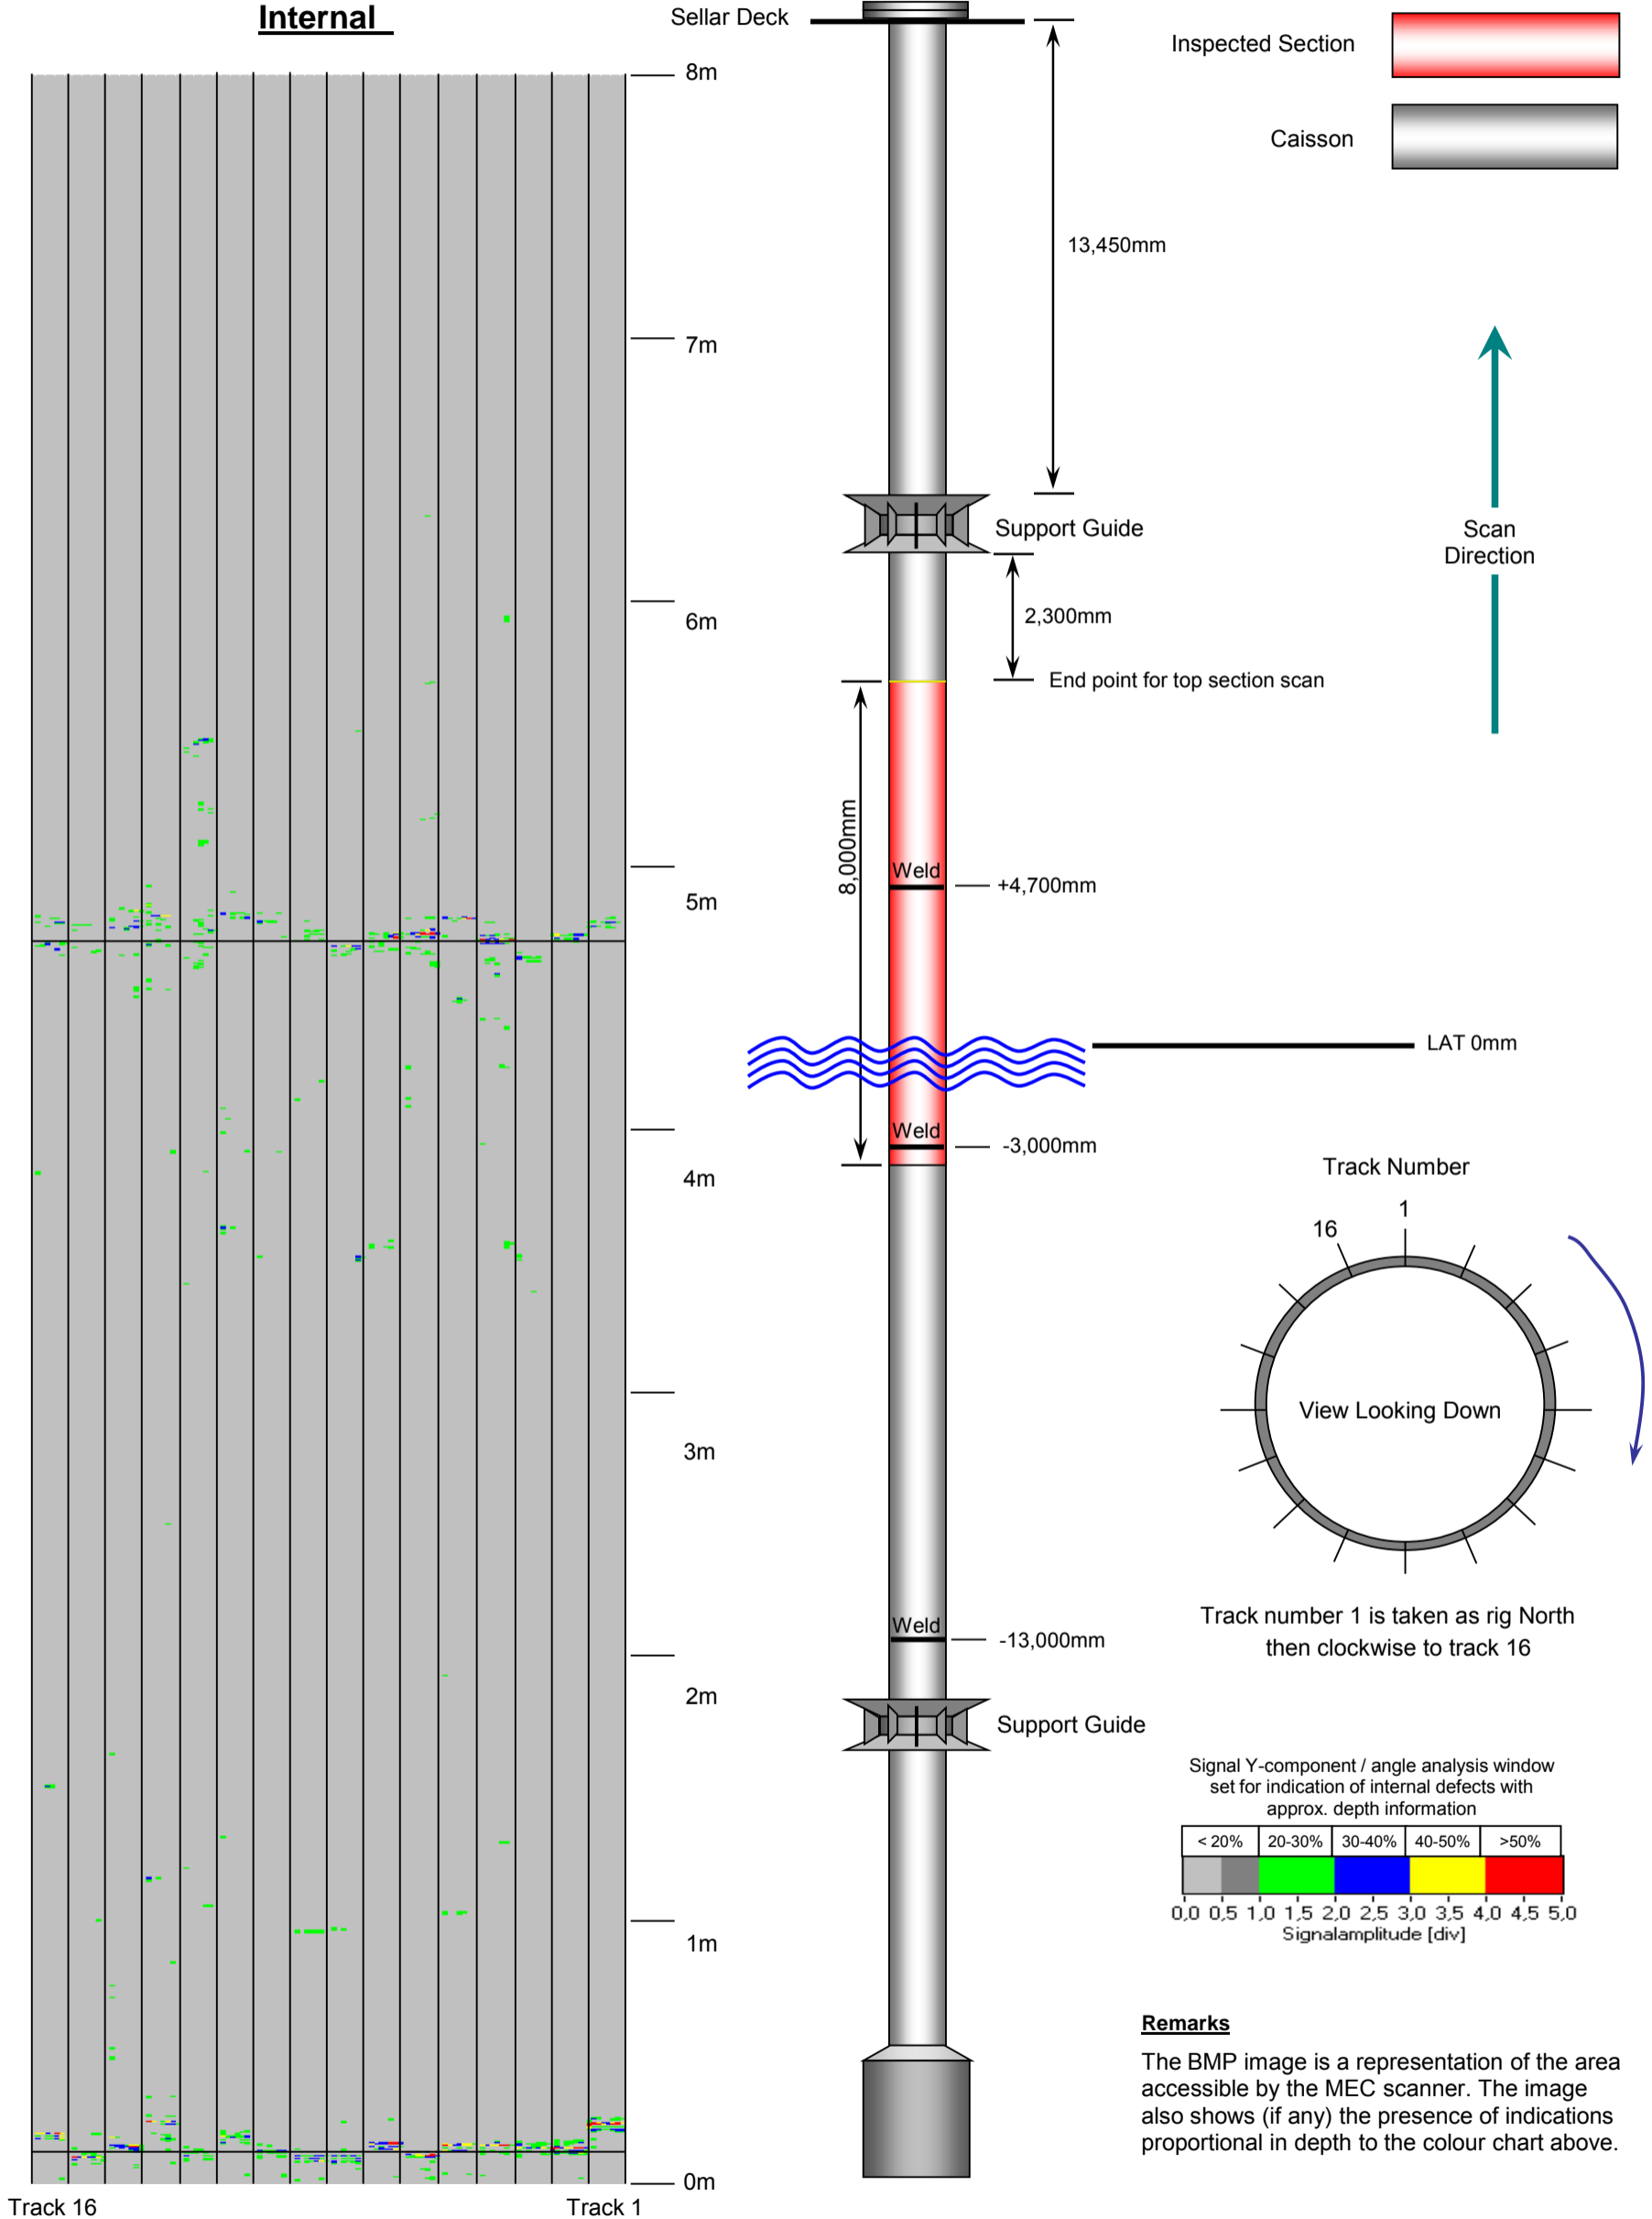
Indication View Section 2

Section 2 (25mm Wall) showed no significant indications
