# IRIS BOILER TUBE INSPECTION CLIENT LOCATION

**Item Inspected** BOILER No1 MAIN BANK TUBES

**Type of Report** FINAL

**Report Number** J0001-09ME

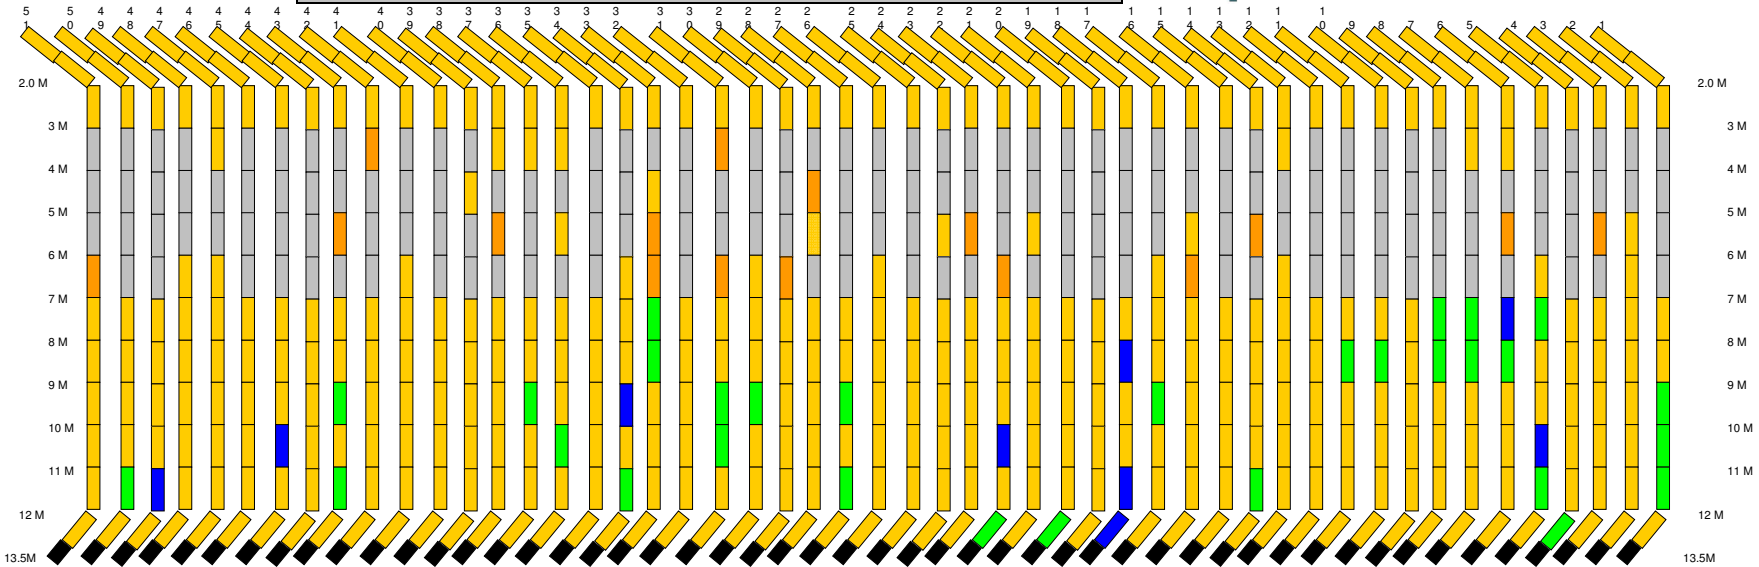
**CROSS SECTION VIEW BY ROW**  
**ROW 02**

Some wastage was detected in the first 6 – 7 meter from the mud drum of this row. The first 8 meters of tubing from the Steam drum have been replaced with 5 mm tubing.
