# IRIS TUBE INSPECTION

**Item Inspected:** Unit 123

**Inspection Method:** IRIS (Ultrasonic)

**Report Number:** K0xx-15 (Jxx22)

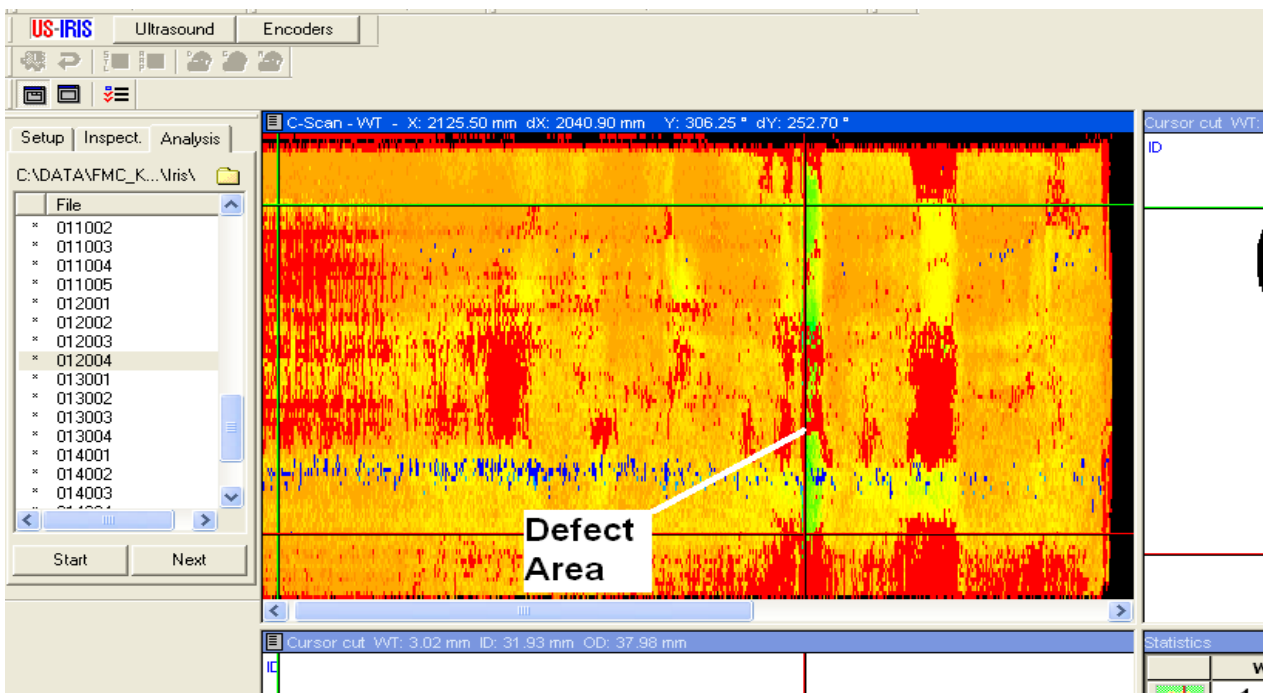
**Figure 1**

General external tube wall damage was noted at the support plates, being in a selection of the tubes examined. This is depicted within appendix 1 which shows an overall defect picture, taken at the tube-sheet identifying (per legend) the maximum wall losses per tube.

Below is one of the actual `C-Scan' images taken from an inspected tube within Unit 123, this clearly showing a reduction to the external tube wall at the support plate positions.

**Actual IRIS Scan taken from Unit 123 depicting wall loss at the support plate**

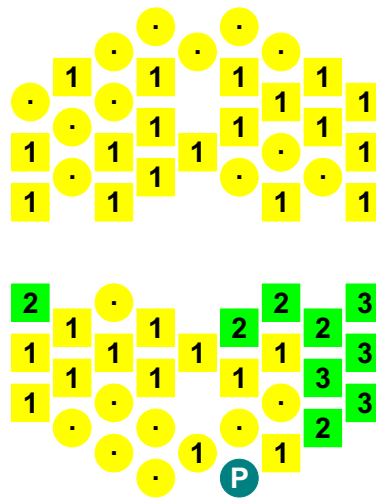
### **Defect Picture**

Of note and clearly seen within the appendices, was the detection and resolution of external tube wall damage at the support plates.
