SLOFEC LS120 Pipe Inspection

Items Inspected: 6" pipeline

Type of Report: Final

Report Number: K00x-16US

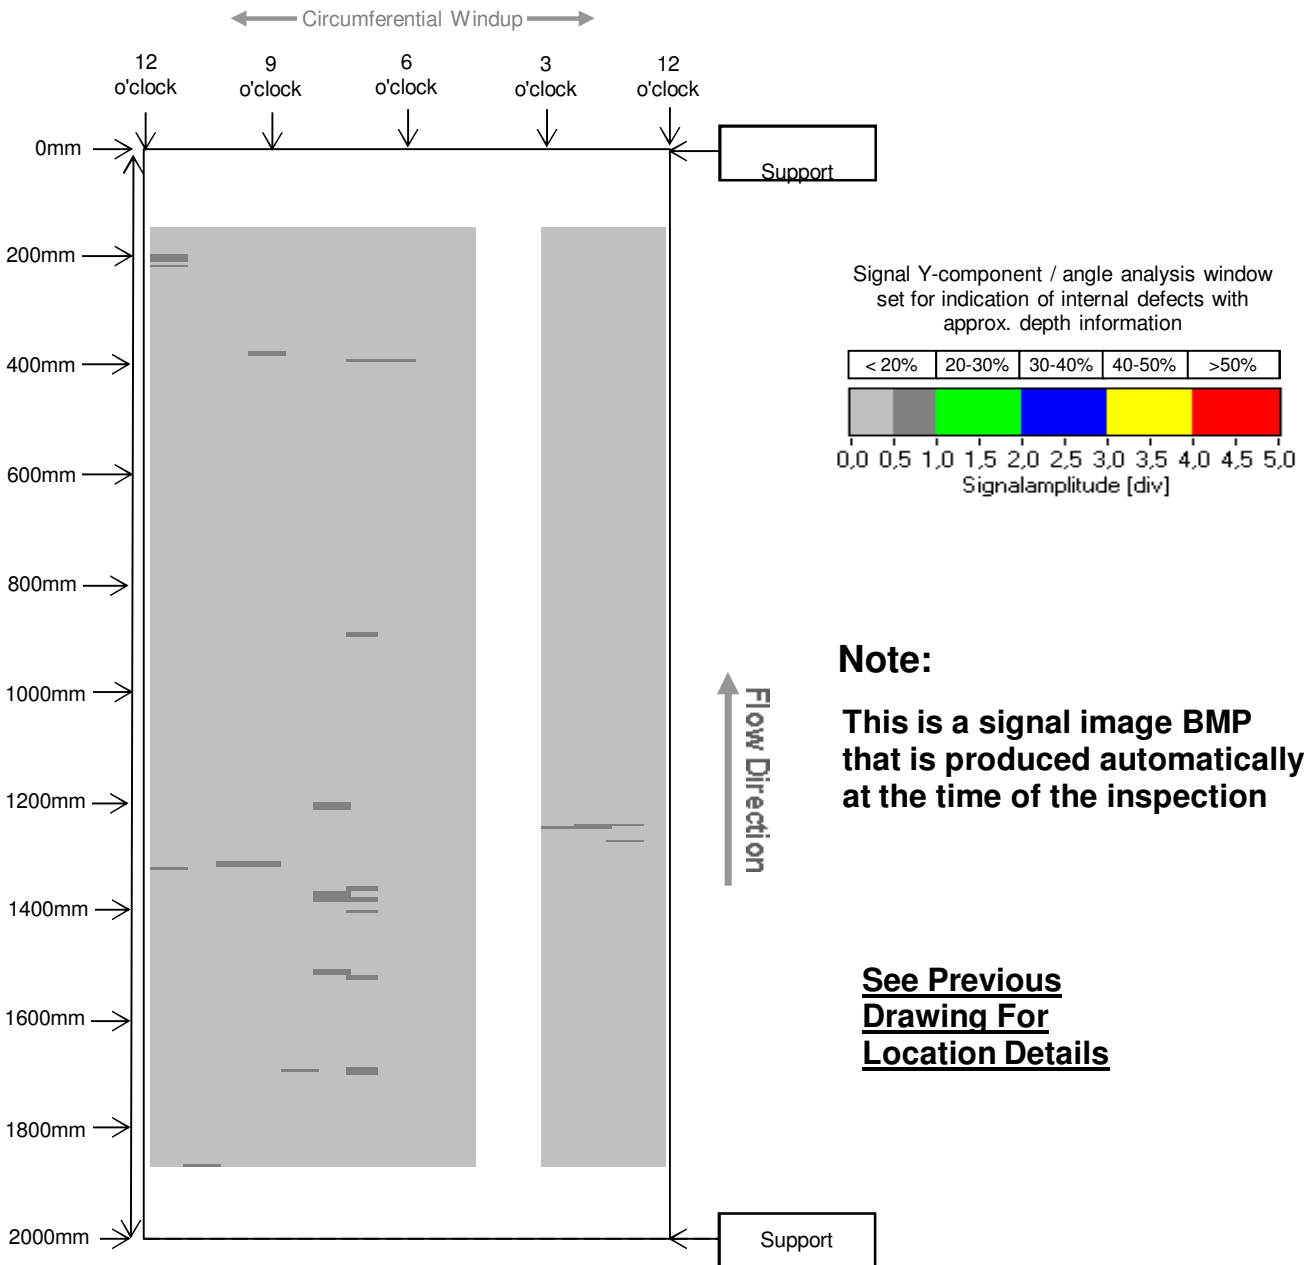
Client Client a
 Location site b
 Pipe Identif. 6
 Drawing 01
 Area 5H
 Section Section 22 (2.84 Metre)
 Date 26 April 2016
 K-No. 00-16

Four sections (22, 40, 48 & 49) of this pipeline were found to have isolated random indications with 20%-30% wall loss.

Four pipe sections of numbers 22, 40, 48 & 49, were found with isolated 20-30% wall loss random indications. Ultrasonic's was carried out on these areas however with the manual UT equipment available and difficult access in these areas, no confirmation was possible. These signals were classic Differential Eddy Current lissajous (Slofec) signals and repeatable, hence these have been left in for reference.
