MEC™ Pipe Seam Weld Inspection

Client: Client a

Items Inspected: 12.75" OD - Steel Pipe

Report Number: K-00x-1xxx

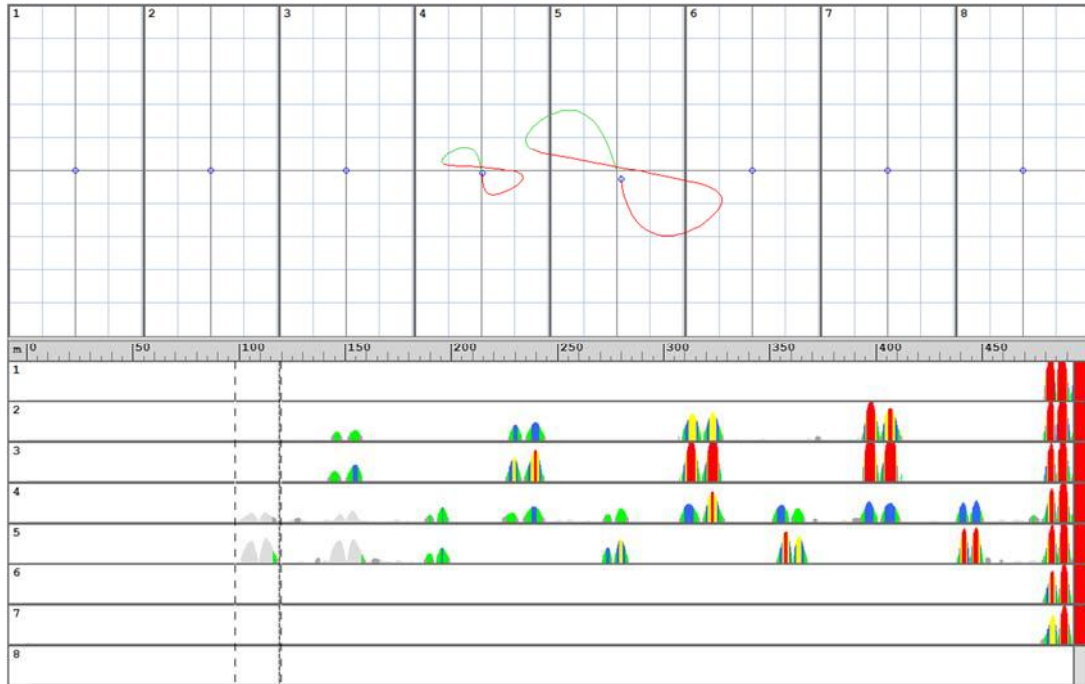
The calibration signal below depicts a 20% wall loss reference external surface indication, with the underside parameter settings active. A surface indication is distinguished clearly due to a horizontal shift in the (impedance) phase angle of approximately 90°, when compared to that of an internal (vertical) defect indication (page 17). Surface indications are the resultant of a true Eddy Current field disturbance/response(s).

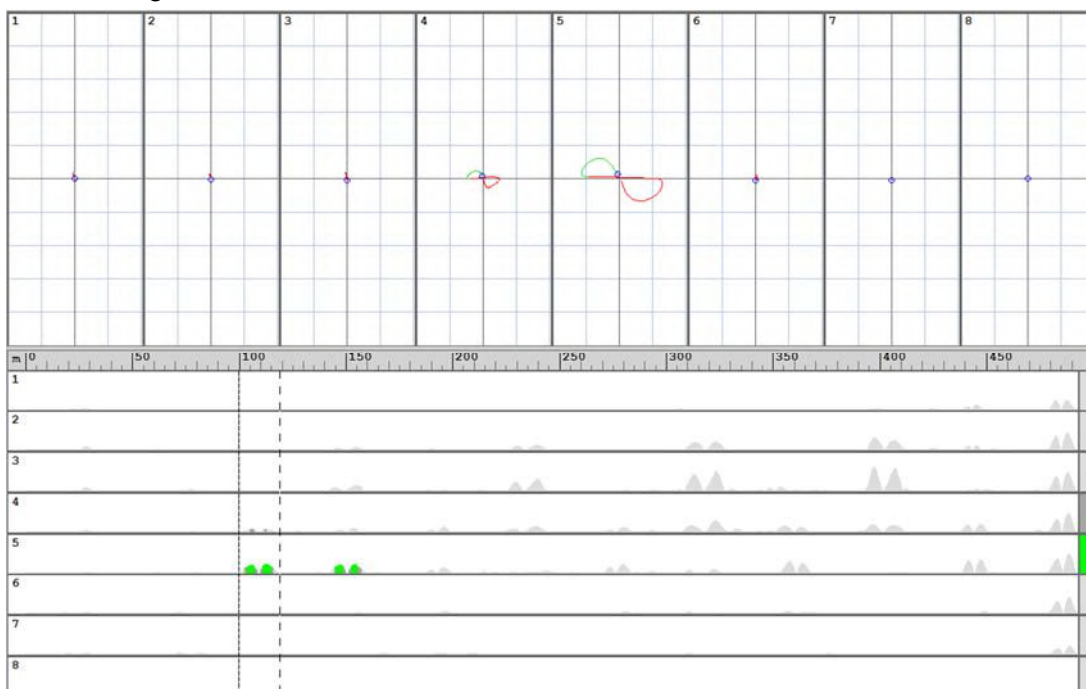
The calibration signal showing below is a 20% wall loss surface indication, with the topside parameter settings active

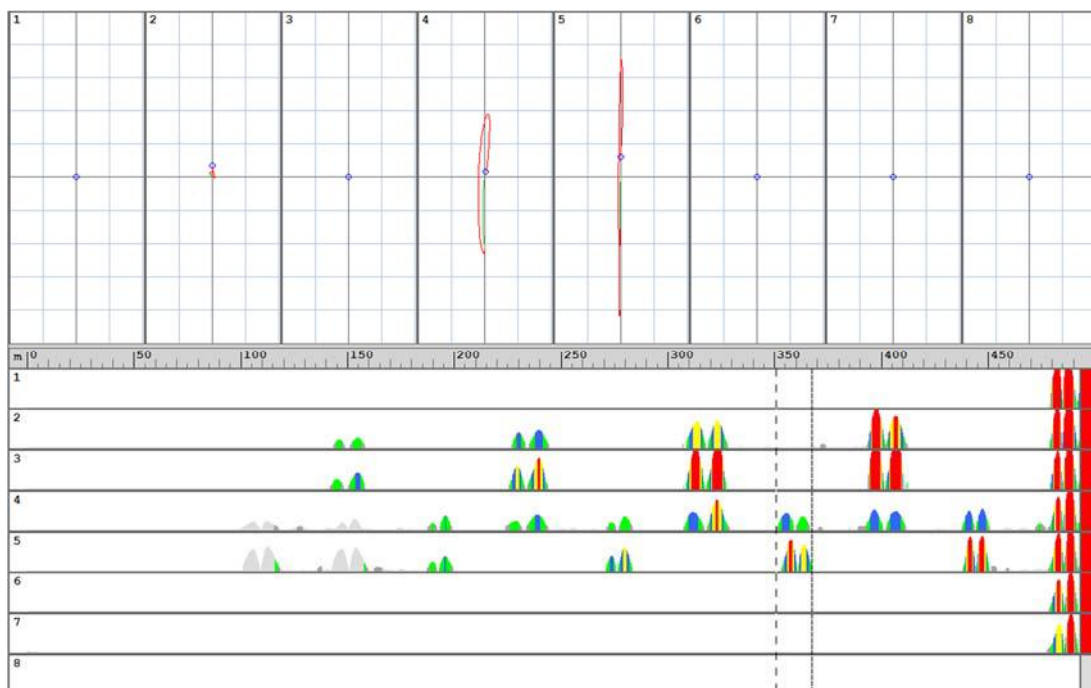
The calibration signal shown below is that of a 60% wall loss underside defect indication, with the underside parameter settings active. This indication is shown set vertically at 8 screen divisions, and is the main inspection sensitivity level.

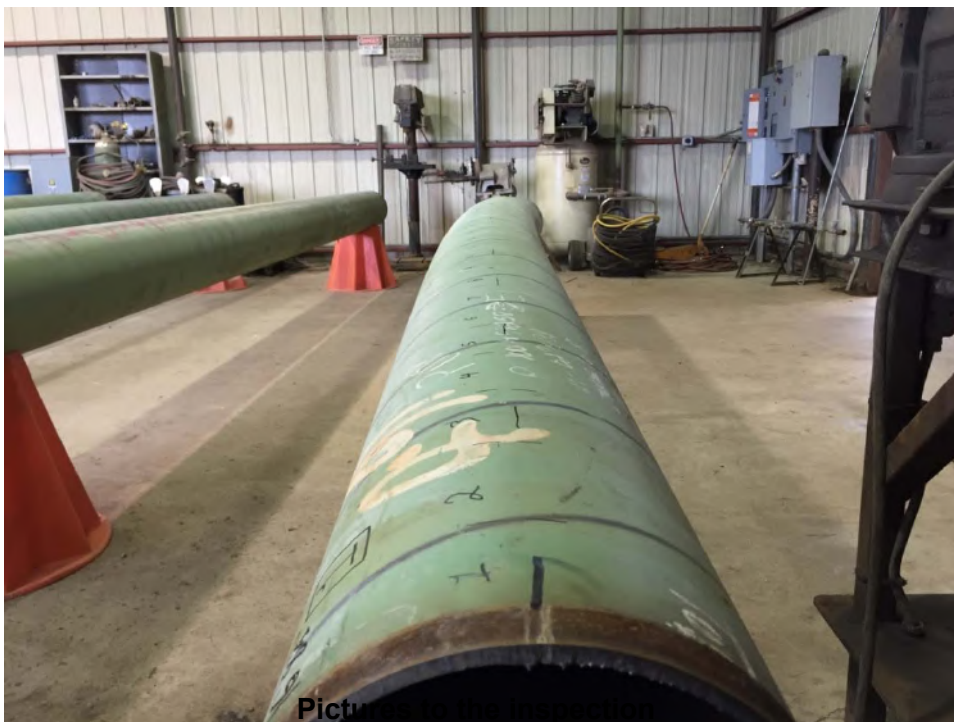
- Pipe samples were clean and free of debris
- The inspection was in a clean, quiet environment
- Some pipes were slightly bent with ovality.

Pipe section number 1, exhibits a slight bend giving rise to some minor pipe ovality which has the effect of raising and lowering lift off, (the distance between the sensor pole shoe and the inspected material) giving rise to gradual sensitivity variations.

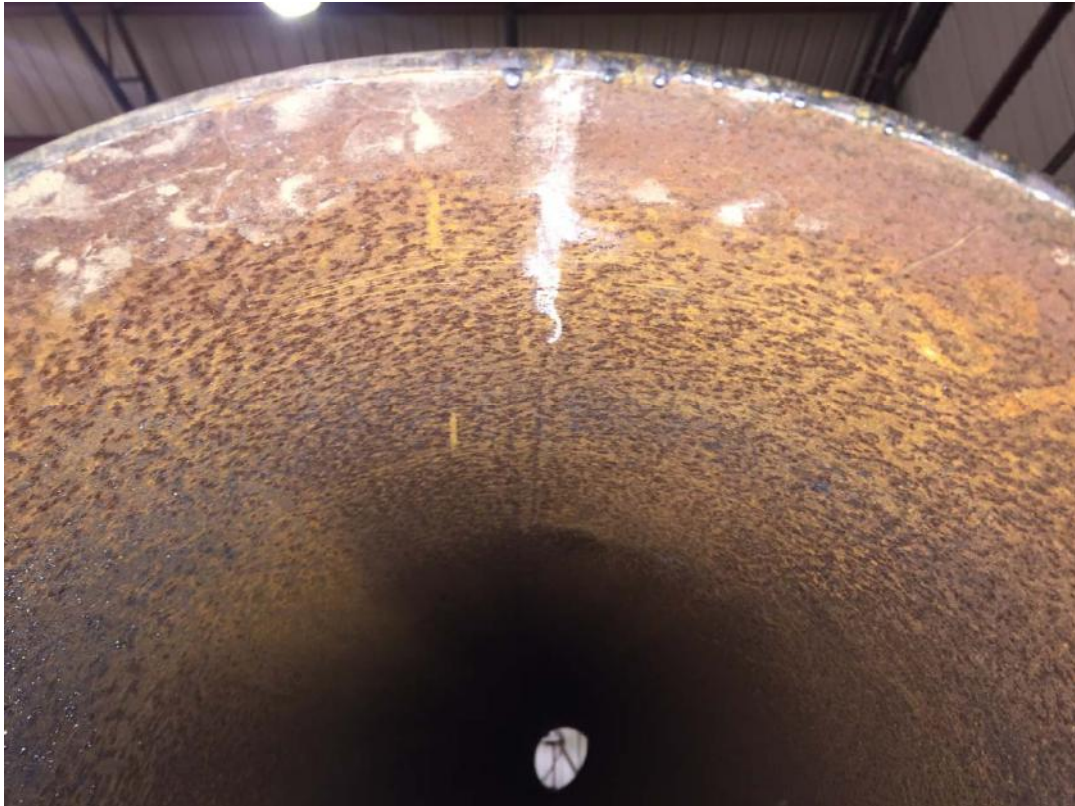
This view shows the smooth profile of the weld from the internal surface
