Air Diving Inspection of ABC Mock-Up Caisson Project 123

Item Inspected: ABC Mock-Up Caisson

Inspection Method: Manual Surface Eddy Current

Report Number: K1912

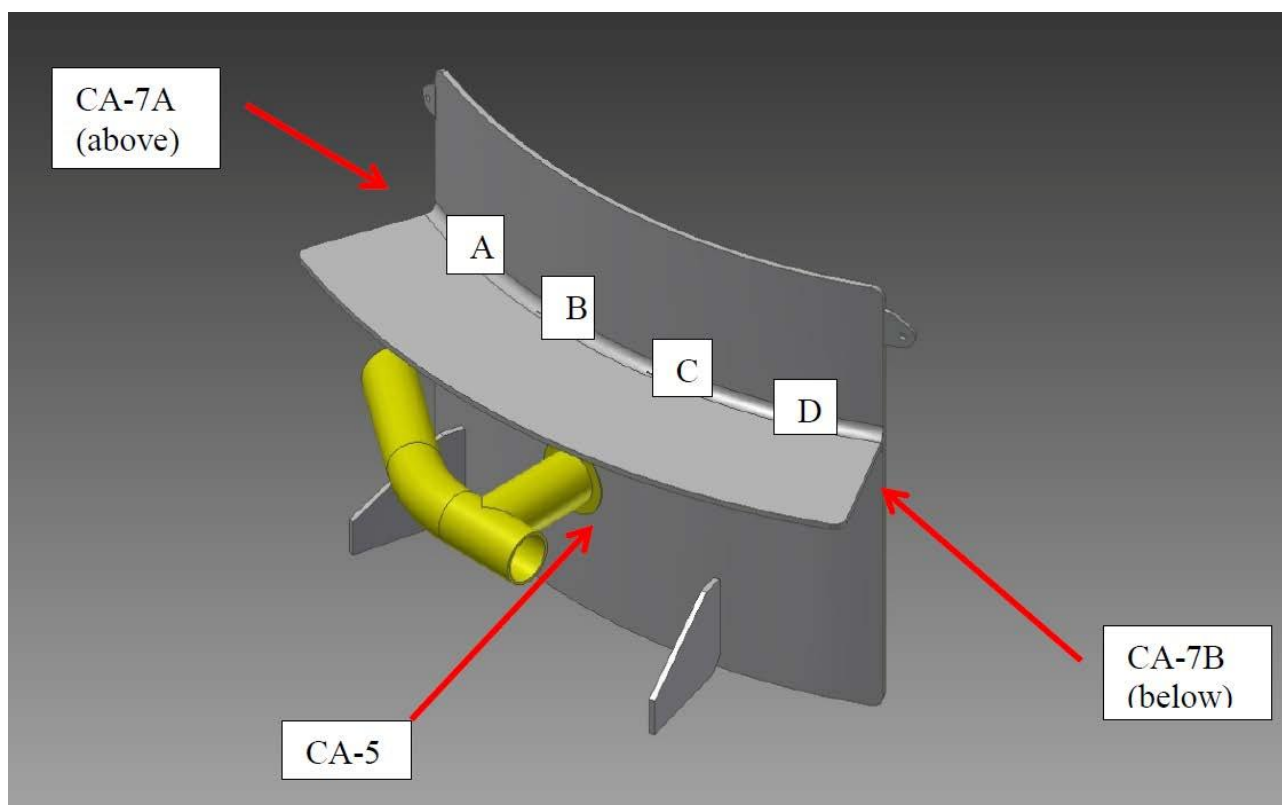
Picture 3: ABC caisson mock-up showing inspection locations.

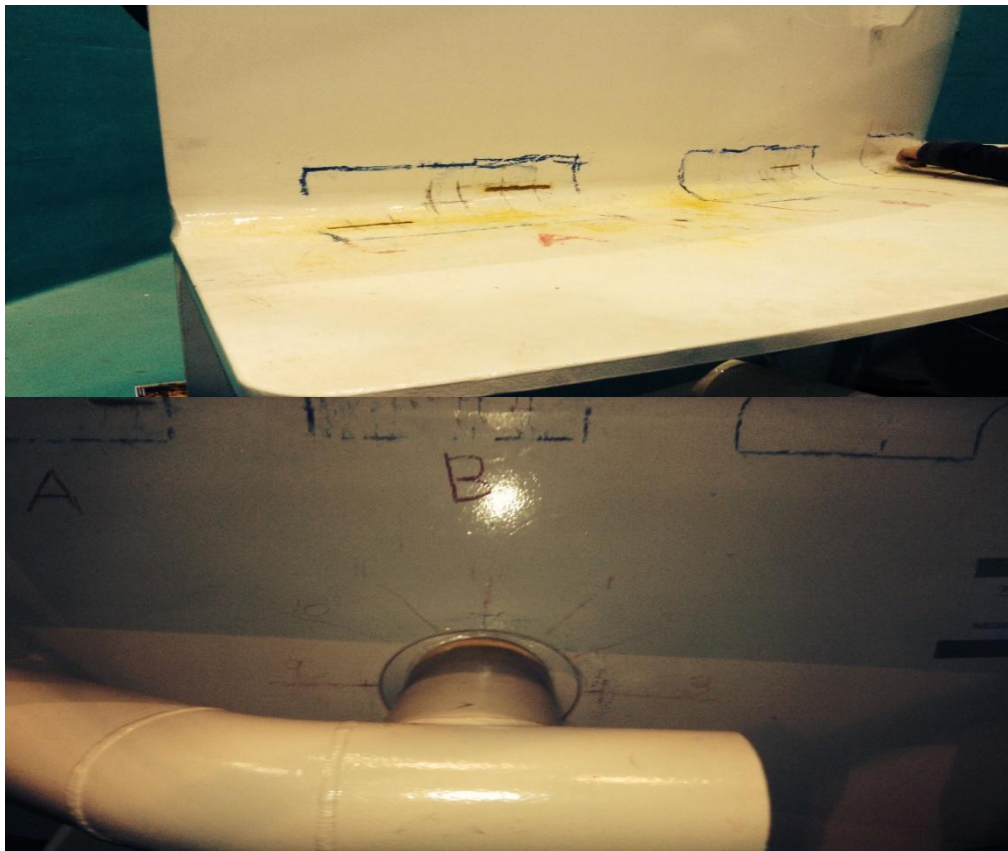
Picture 9 and 10: Showing inspected area locations.

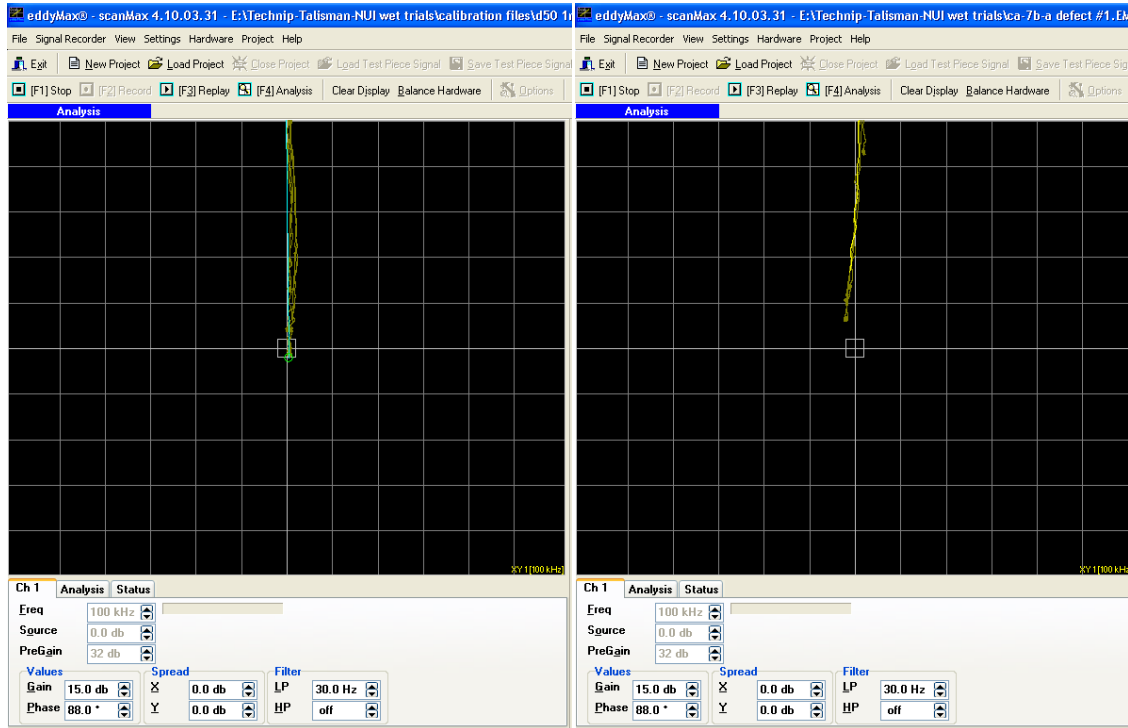
Picture 11 and 12: Showing signal comparison.

Picture 11 shows signal response from 50D test sample block EDM spark eroded notch 1.0 mm depth. Picture 12 shows signal response from defect at location CA-7B-A, 1 upper toe.
