# SLOFEC™ LS150 & ULTRASONIC VESSEL INSPECTION

**Items Inspected:** BT Vessel

**Type of Report:** Final Report

**Report Number:** K0xx-13/Jxx22

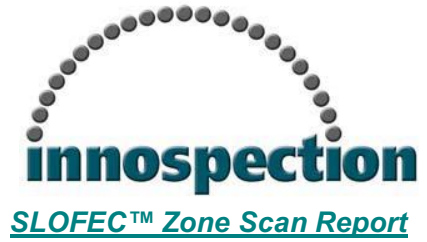
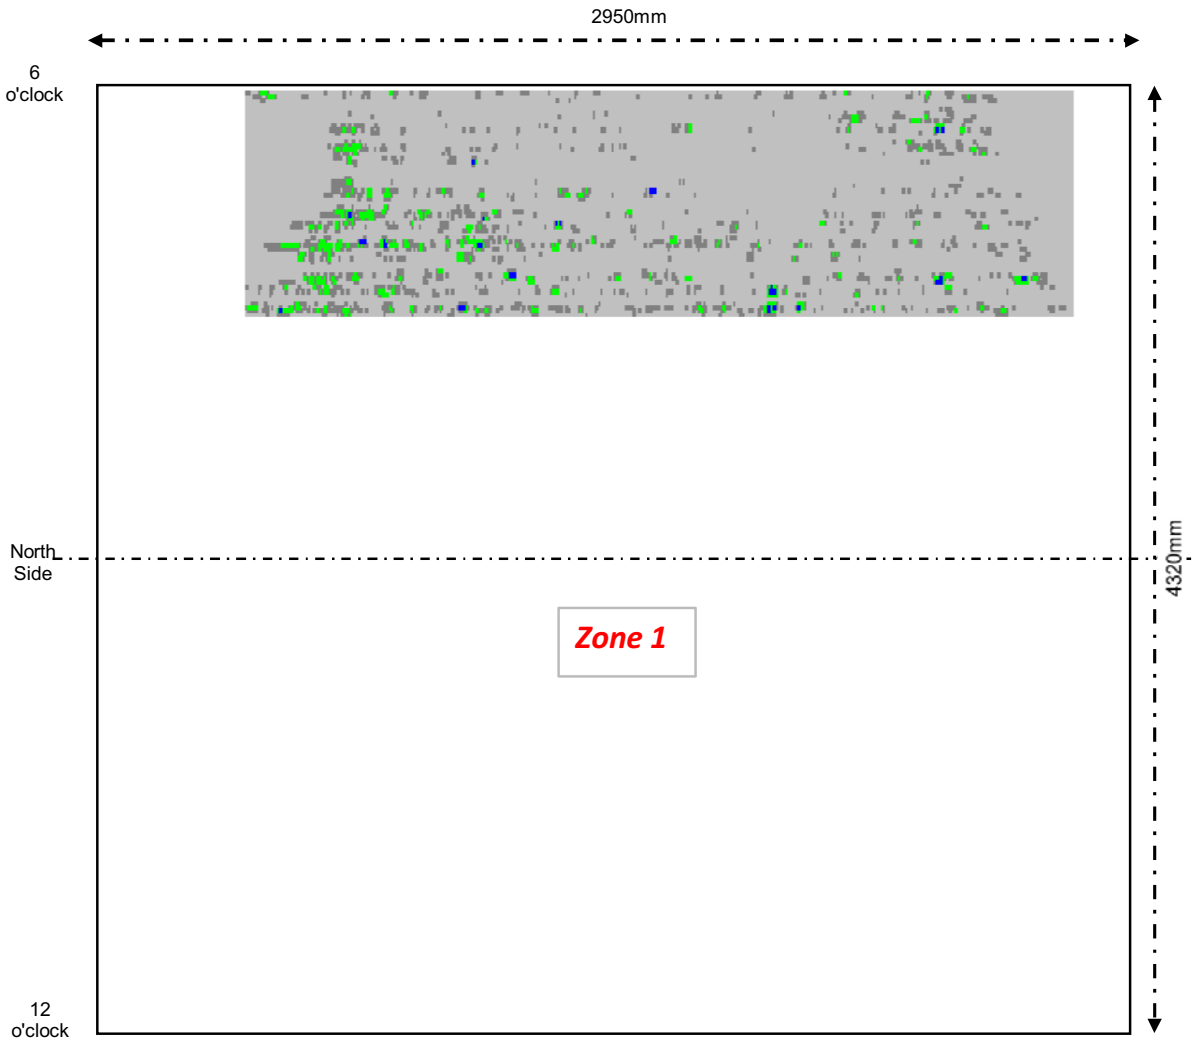
**Zone 1**  
13 to 18 January 2014  
0xx-13

Signal Y-component / angle analysis window  
set for indication of internal defects with  
approx. depth information

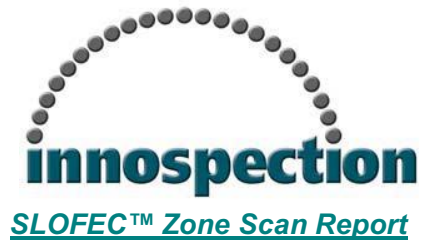
**Zone 2**  
13 to 18 January 2014  
0xx-13

The lowest ultrasonic wall thickness measured, was found in zone 2 (please see the included appendix mapping), where a result of 3.6mm remaining wall was indicated.

Signal Y-component / angle analysis window  
set for indication of internal defects with  
approx. depth information

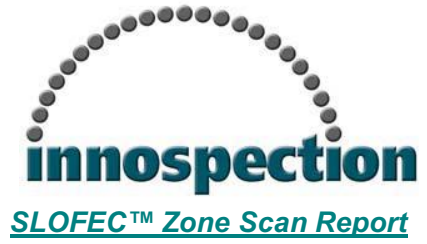
**Zone 3**  
13 to18 January 2014  
0xx-13

Signal Y-component / angle analysis window  
set for indication of internal defects with  
approx. depth information

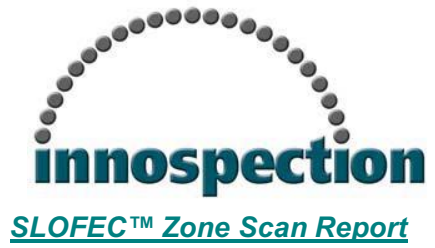
**Zone 4**  
13 to 18 January 2014  
0xx-13

Signal Y-component / angle analysis window  
set for indication of internal defects with  
approx. depth information

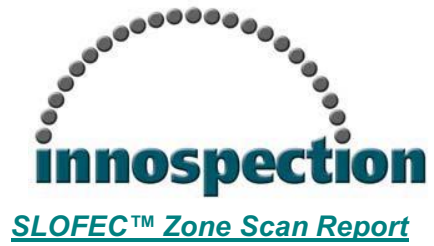
**Zone 5**  
13 to18 January 2014  
0xx-13

Signal Y-component / angle analysis window  
set for indication of internal defects with  
approx. depth information

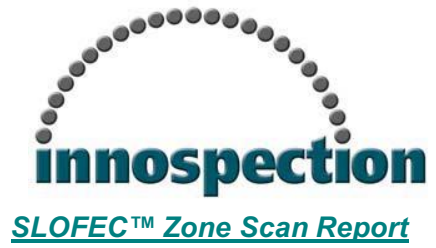
**Zone 6**  
13 to 18 January 2014  
0xx-13

Signal Y-component / angle analysis window  
set for indication of internal defects with  
approx. depth information
