# IRIS TUBE INSPECTION

**Item Inspected:** Unit 123

**Inspection Method:** IRIS (Ultrasonic)

**Report Number:** K0xx-15 (Jxx22)

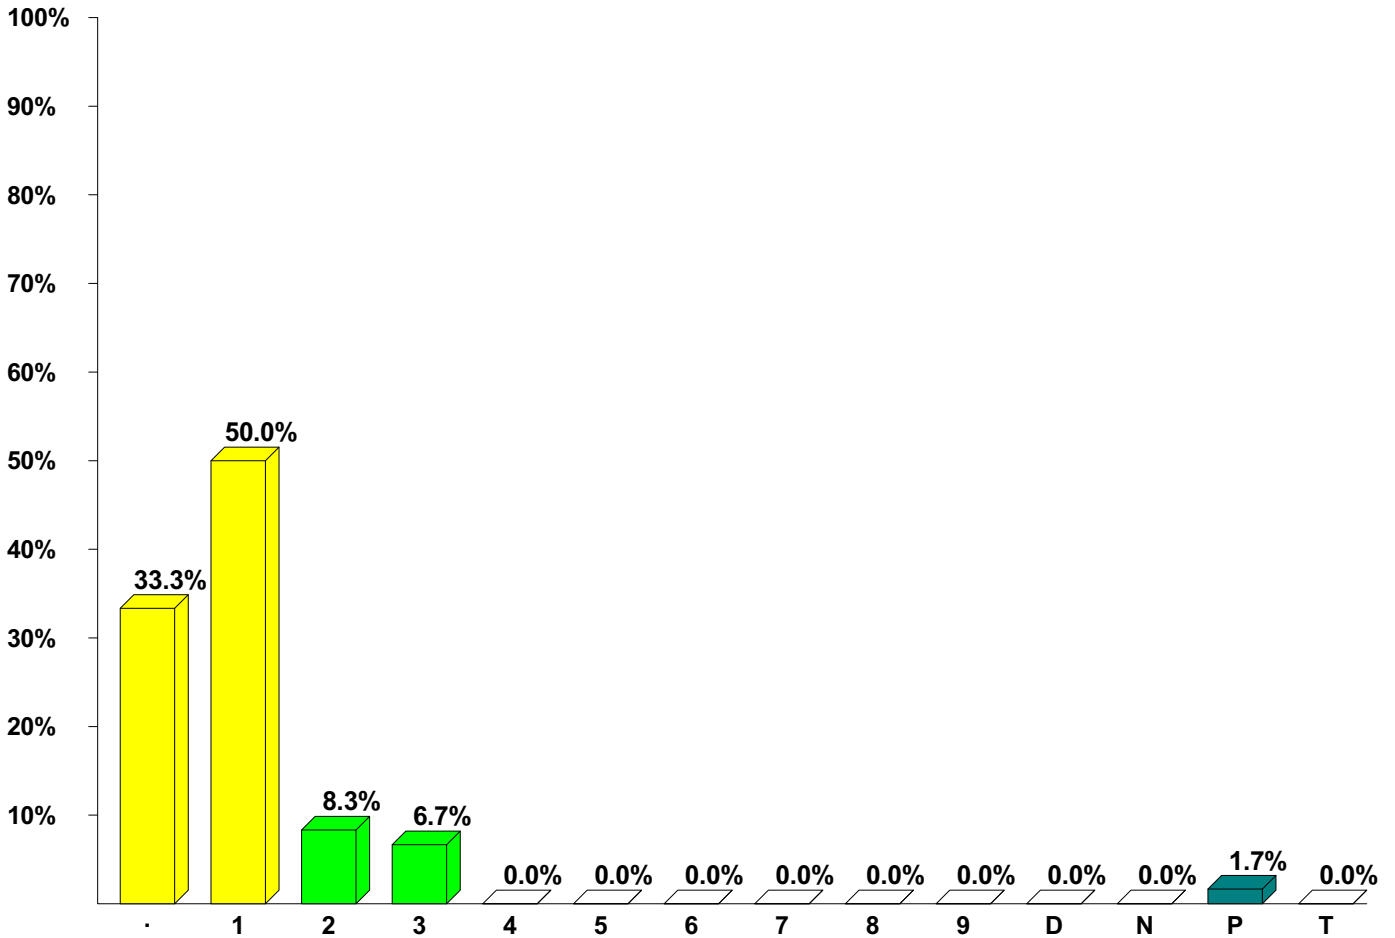
**Unit 123 - Statistic  
final result - all section  
(100% = all tubes)**

[1] : all tubes	60			
[2] : all tubes with indication	39		65.0% from [1]	
[3] : all inspected tubes	59		98.3% from [1]	
<b>internal defects</b>	<b>number</b>	<b>% [1]</b>	<b>% [2]</b>	<b>% [3]</b>
1 10% - 19%	0	0.0	0.0	0.0
2 20% - 29%	0	0.0	0.0	0.0
3 30% - 39%	0	0.0	0.0	0.0
4 40% - 49%	0	0.0	0.0	0.0
5 50% - 59%	0	0.0	0.0	0.0
6 60% - 69%	0	0.0	0.0	0.0
7 70% - 79%	0	0.0	0.0	0.0
8 80% - 89%	0	0.0	0.0	0.0
9 90% - 100%	0	0.0	0.0	0.0
<b>external defects</b>	<b>number</b>	<b>% [1]</b>	<b>% [2]</b>	<b>% [3]</b>
1 10% - 19%	30	50.0	76.9	50.8
2 20% - 29%	5	8.3	12.8	8.5
3 30% - 39%	4	6.7	10.3	6.8
4 40% - 49%	0	0.0	0.0	0.0
5 50% - 59%	0	0.0	0.0	0.0
6 60% - 69%	0	0.0	0.0	0.0
7 70% - 79%	0	0.0	0.0	0.0
8 80% - 89%	0	0.0	0.0	0.0
9 90% - 100%	0	0.0	0.0	0.0
	<b>number</b>	<b>% [1]</b>	<b>% [2]</b>	<b>% [3]</b>
● No defect	20	33.3		33.9
○ Dent	0	0.0	0.0	0.0
○ Not decideable	0	0.0	0.0	0.0
○ No throughpass	0	0.0	0.0	0.0
● Plug	1	1.7		
○ Tube not to be inspected	0	0.0
