SLOFEC LS120 Pipe Inspection

Items Inspected: 6" pipeline

Type of Report: Final

Report Number: K00x-16US

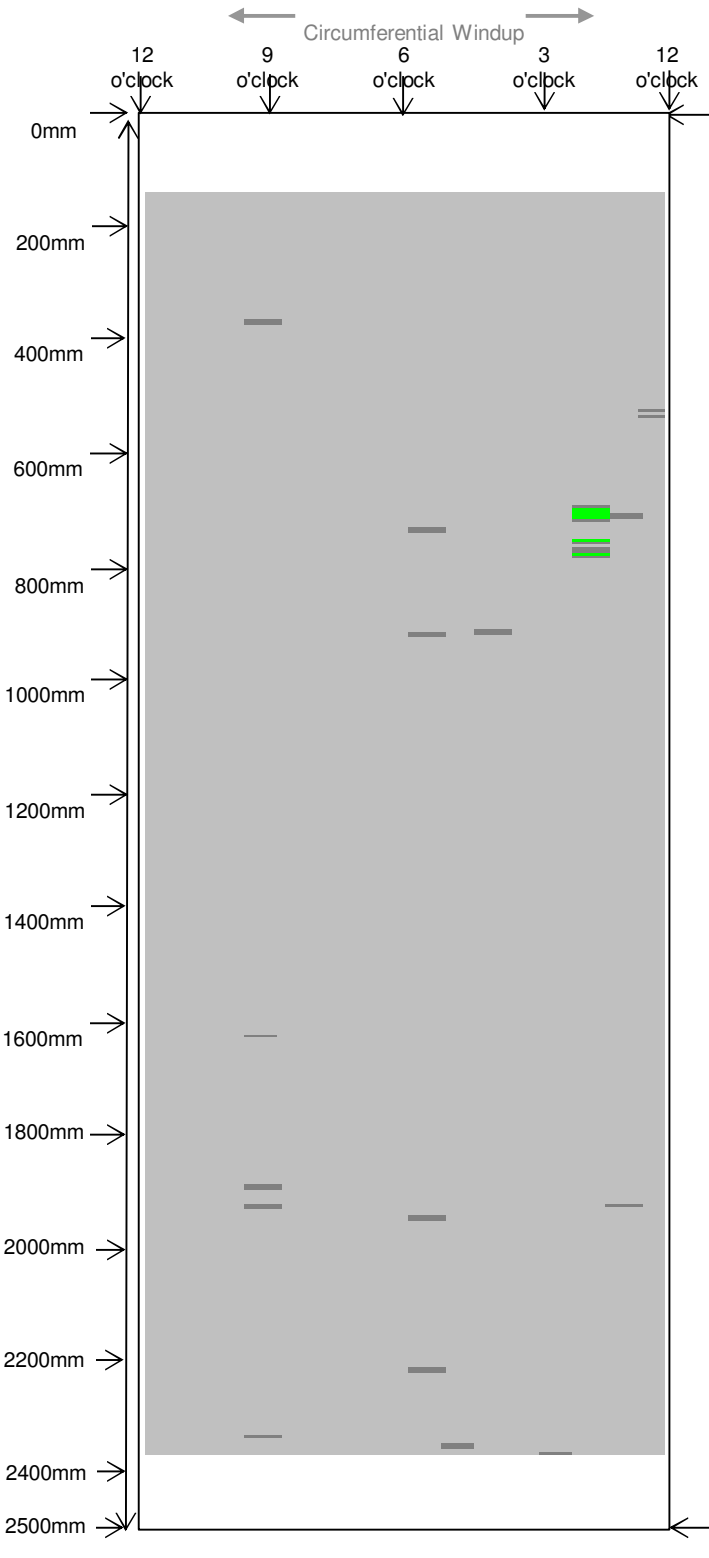
Signal Y-component / angle analysis window
 set for indication of internal defects with
 approx. depth information

< 20%	20-30%	30-40%	40-50%	>50%
-------	--------	--------	--------	------
