MEC™ Pipe Seam Weld Inspection

Client: Client a

Items Inspected: 12.75" OD - Steel Pipe

Report Number: K-00x-1xxx

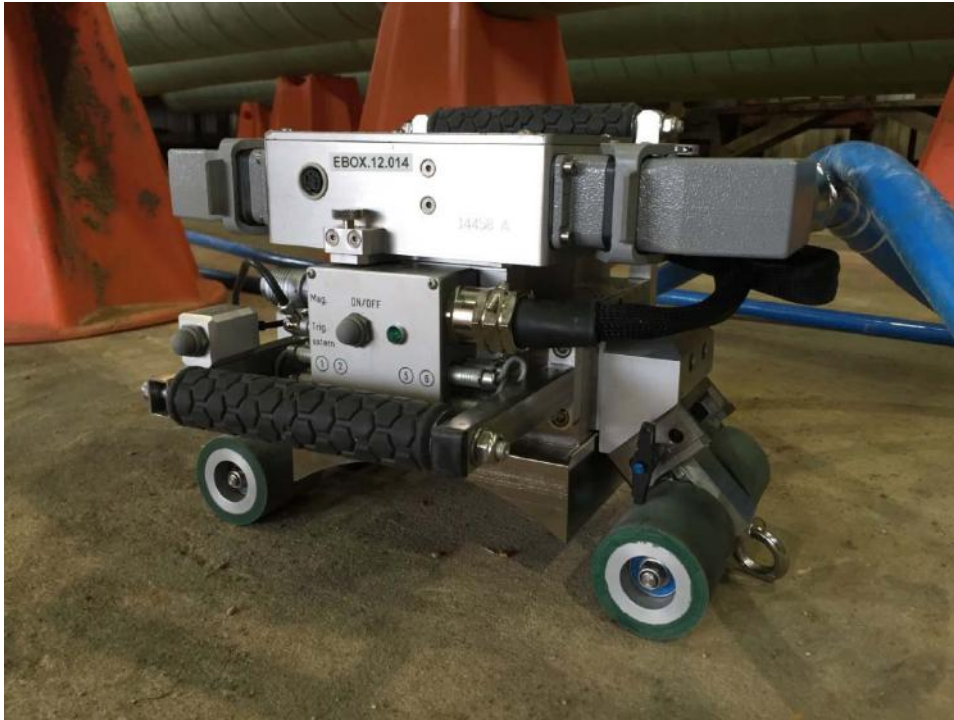
Pipe section number 1, exhibits a slight bend giving rise to some minor pipe ovality which has the effect of raising and lowering lift off, (the distance between the sensor pole shoe and the inspected material) giving rise to gradual sensitivity variations.
