SLOFEC
&
Specialised Ultrasonics
Vessel Inspection Project

Platform A-

March 2004

External vessel inspection VJ 20001 A
Platform ABC
March 2004

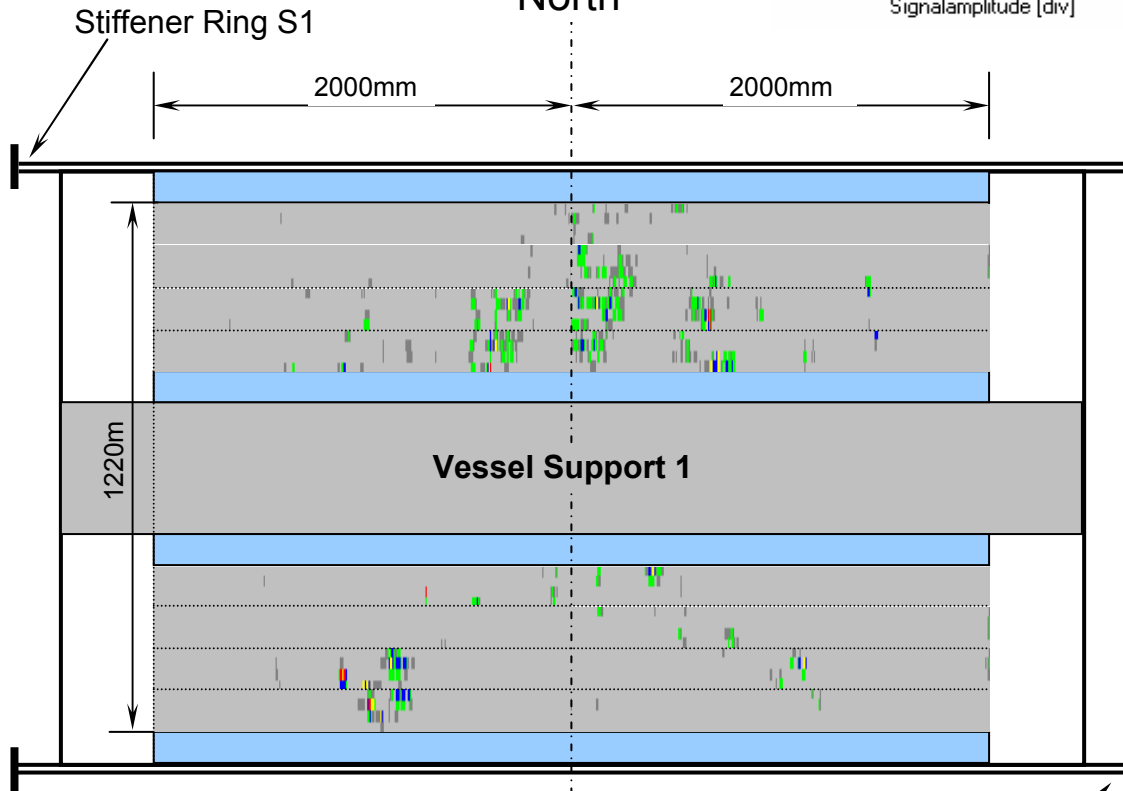
Section Area A2

Viewed from inside the Vessel and facing to the North

Signal Y-component / angle analysis window set for indication of internal defects with approx. depth information

Dead Zone Area

Stiffener Ring S2

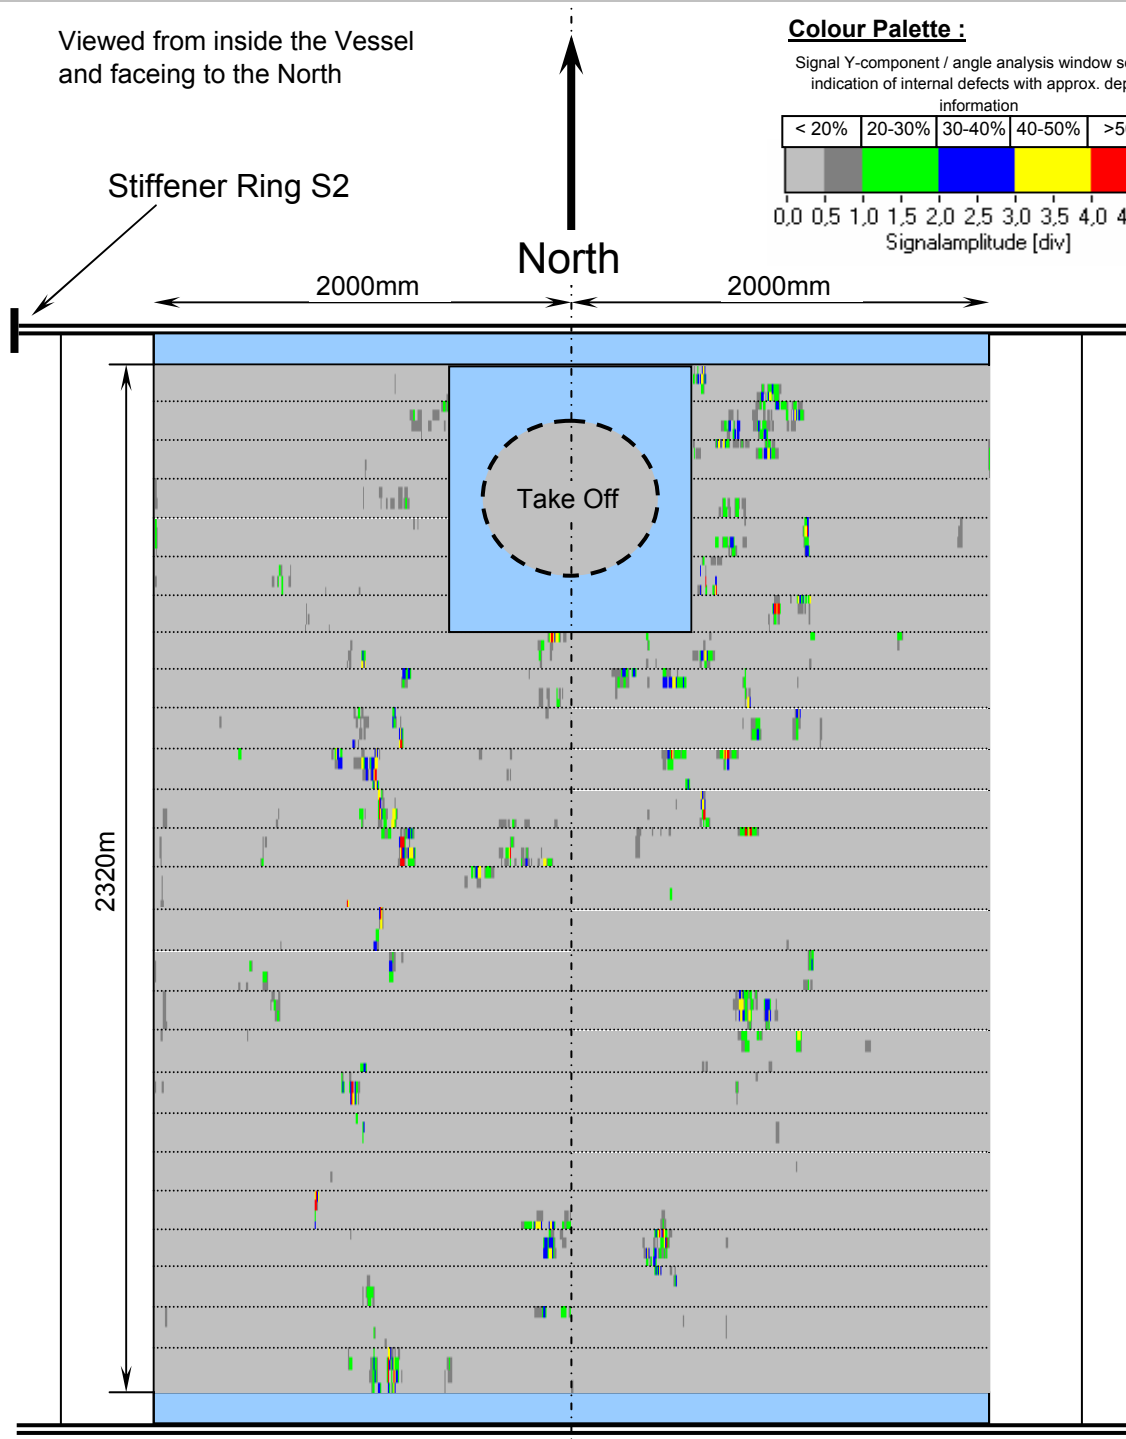
Section Area A3

Viewed from inside the Vessel and facing to the North

Signal Y-component / angle analysis window set for indication of internal defects with approx. depth information

Dead Zone Area

Stiffener Ring S3
